Aerial Remote Sensing of Ground-Water Contamination Sources

Eastern
San Fernando
Valley: 1937-1964

December 1986

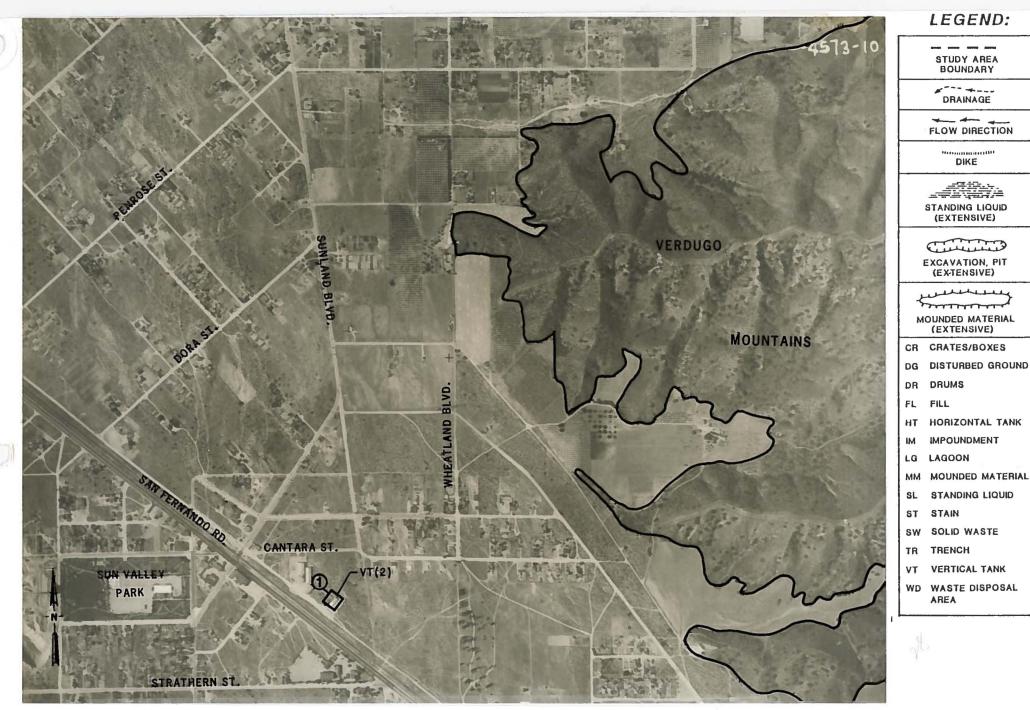
Photograph 4-8. 1937. Approximate scale, 1 inch equals 1,000 feet.

Photo- graph Number	Administrative Area	Major Cross Streets	Potential Contamination Source	Description/Comment
4-8	Los Angeles	Strathern-San Fernando	ol-Fuel Distribution Facility	1 - Two uncontained vertical tanks are present.
4-9	Los Angeles	Clybourn-San Fernando	Tanks (2)	1 - Tanks are associated with a gas station.
	Burbank	Clybourn-Cohasset	2-Mounded Material	2 - Material appears to be sand/gravel stockpiles.
		Clybourn-Cohasset	3-Gravel Pit	3 - Pit is clean.
4-10	Burbank	Clybourn-Empire	1-Mounded Materials	1 - Materials are located behind unidentified commercial facility; appear to be combination of solid waste and clean fill.
		Empire-Hollywood Way	2-Pit	2 - Pit appears to be on Burbank-Union Airport property.
4-11	Los Angeles/ Burbank	-	None Observed	-
4-12	Los Angeles	Hatteras-Clybourn	1-Trench	1 - Feature recently excavated, no visible waste disposal.

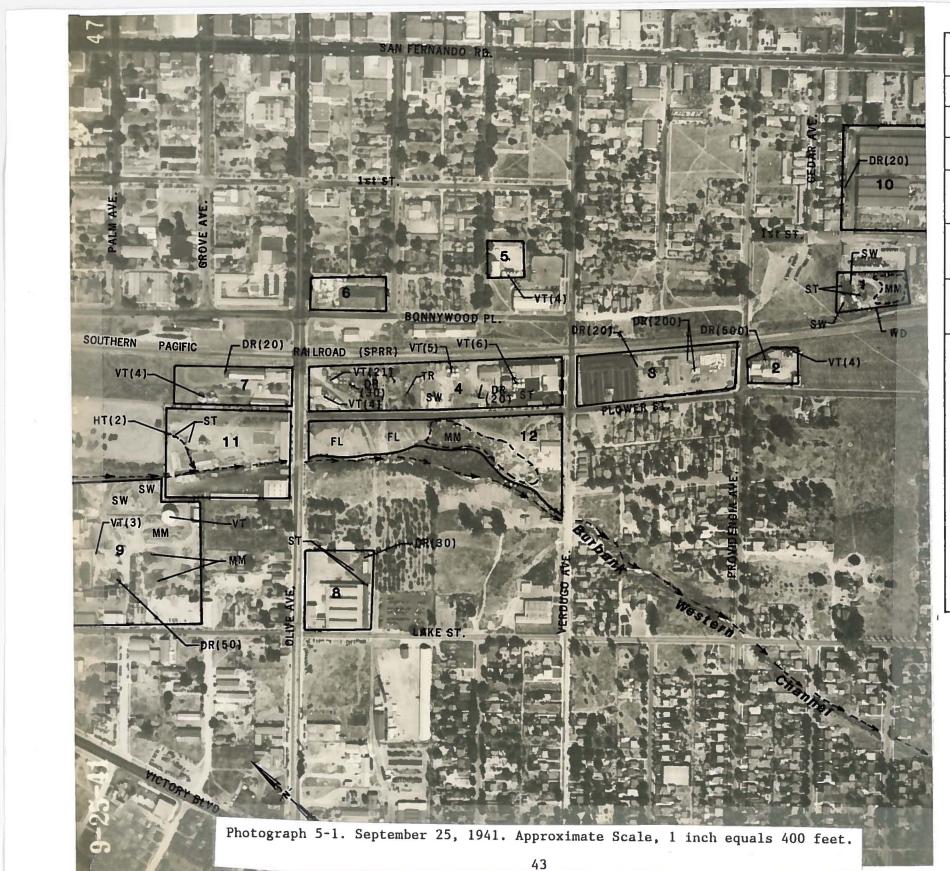
Photo- graph Number	Administrative Area	Major Cross Streets	Potential Contamination Source	Description/Comment	Change from 1937	
5-1	Burbank	lst & Cedar	1-Waste Disposal Area	1-Area appears to have received solid and semisolid (wet solid) wastes. Extensive ground stains present.	1-1937 Photocoverage Unavailable	
	Burbank	Providencia & Flower	2-Fuel Distribution Facility	2-Four uncontained vertical tanks and approx. 500 55-gallon drums on site	=	
	Burbank	Verdugo & Flower	3-Unidentified Industrial Facility	3-Manufacturing treating facility using thermal process; approx. 220 55-gallon drums on site.	3-1937 Photocoverage Unavailable	
	Burbank	Olive & Flower	4-Petrochemical Processing Storage/Distribution Facility	4-On site are 36 vertical storage tanks, approx. 50 55-gallon drums, a solid waste pile, trench, and ground stains.	4-1937 Photocoverage Unavailable	
	Burbank	Verdugo & 1st	5-Fuel Distribution Facility	5-On site are 4 contained vertical storage tanks.	5-1937 Photocoverage Unavailable

Burbank	Olive & 1st	6-Lumber Processing Facility	6-No visible pollution signs.	6-1937 Photocoverage Unavailable	
	Burbank	Olive & Flower	7-Fuel Distribution Facility	7-On site are 4 contained vertical storage tanks and 20 55-gallon drum	7-1937 Photocoverage Unavailable s.	
	Burbank	Olive & Lake	8-Light Manufacturing Facility	8-Approx. 30 55-gallon drums stored in open; extensive ground stains associated with storage area.	8-1937 Photocoverage Unavailable	
	Burbank	Lake & Magnolia	9-Electrical Generating Facility		9-1937 Photocoverage Unavailable	
	Burbank	San Fernando & Cedar	10-Light Manufacturing Facility	10-Approx. 20 55-gallon drums stored in open on west side.	10-1937 Photocoverage Unavailable	
	Burbank	Flower & Olive	11-Concrete Fabrication and Storage Facility	11-Discharge from two horizontal storage tanks reaches Burbank Western Channel.	11-1937 Photocoverage Unavailable	
,	Burbank	Flower & Olive to Verdugo	12-Waste Disposal/Fill Dumping Area	12-Area has received earthen mate- rial and extensive dumping of oth solids including probable municip wastes and refuse.	er

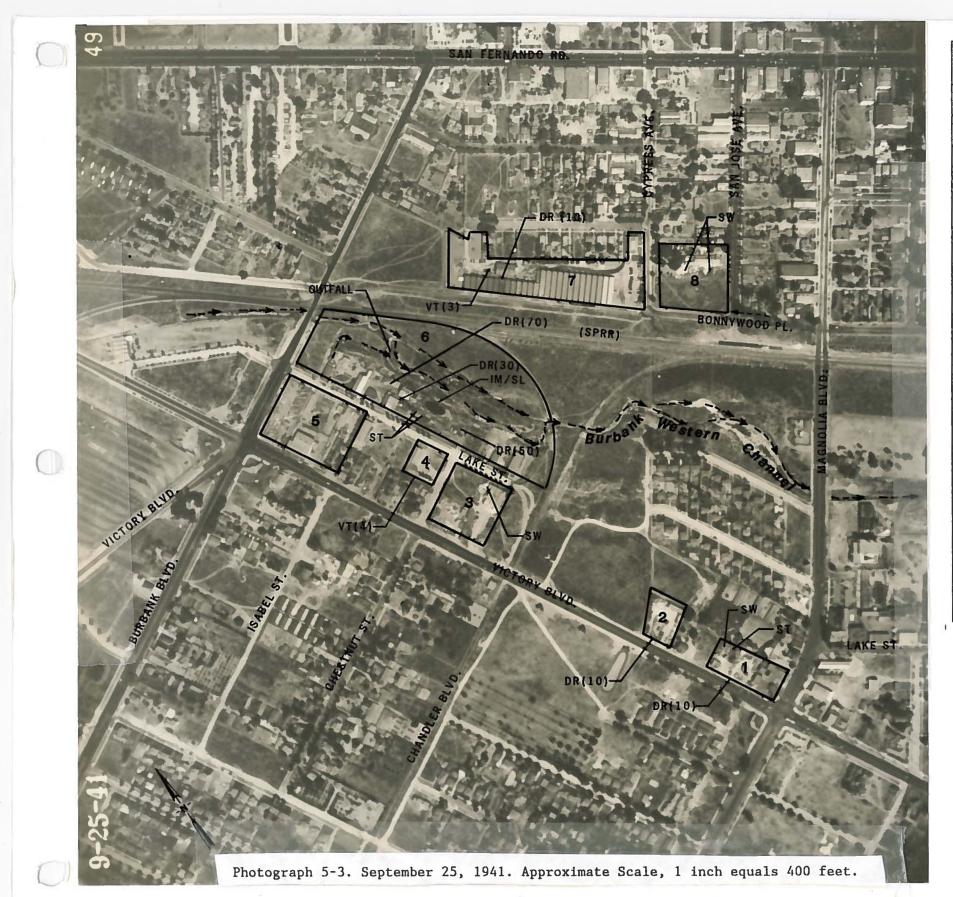
5-2	Burbank	Magnolia & Victory	1-Light Manufacturing Facility	1-On site are ground stains, a solid waste pile, and 10 55-gallon drums.	1-1937 Photocoverage Unavailable	
	Burbank	Magnolia & Victory	2-Lumber Yard	2-On site are approx. 10 55-galion drums.	2-1937 Photocoverage Unavailable	
	Burbank	Chestnut & Victory	3-Light Manufacturing Facility	waste pile.	3-1937 Photocoverage Unavailable	
	Burbank	Lake & Chestnut	4-Fuel Distribution	4-On site are 4 uncontained vertical tanks.		
	Burbank	Victory & Burbank	5-Lumber Yard	5-No visible pollution signs.	5-1937 Photocoverage Unavailable
